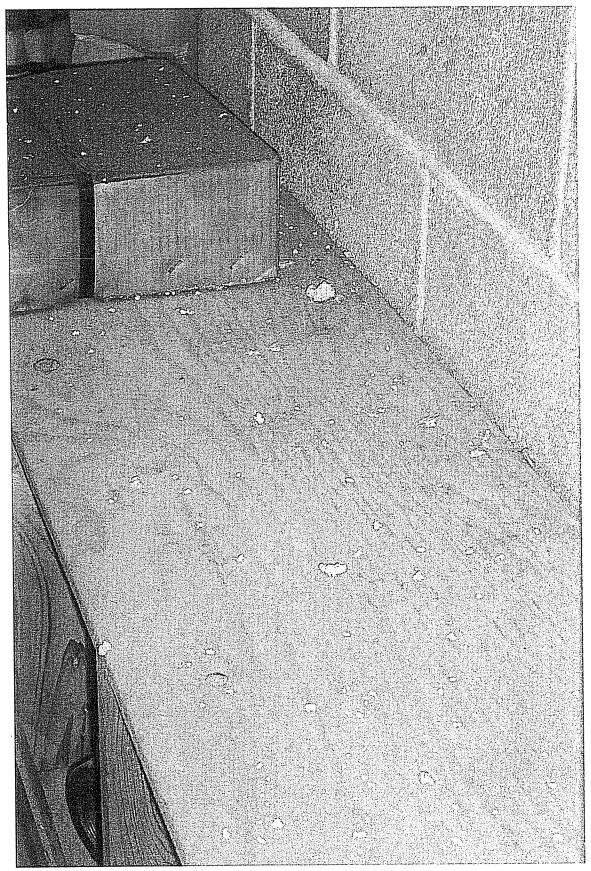
27. parts/stock room - delaminated fireproofing dust and debris along backwall

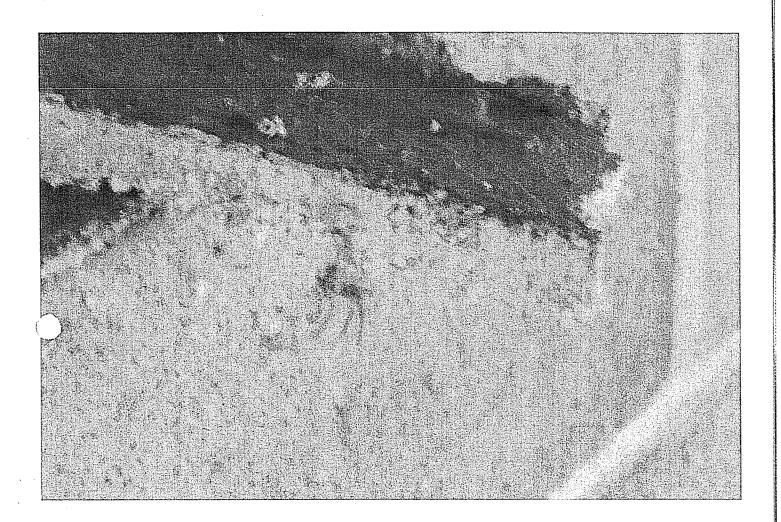
28. parts/stock room - delaminated fireproofing dust and debris along backwall
